# GOLDEN FORENSICS TECHNICAL REPORT

Ruth v. Beartooth Electric Cooperative  
Inc, et. al.  
Case No.: 22-cv-00230-KHR

Clark Wildfire

November 15, 2021

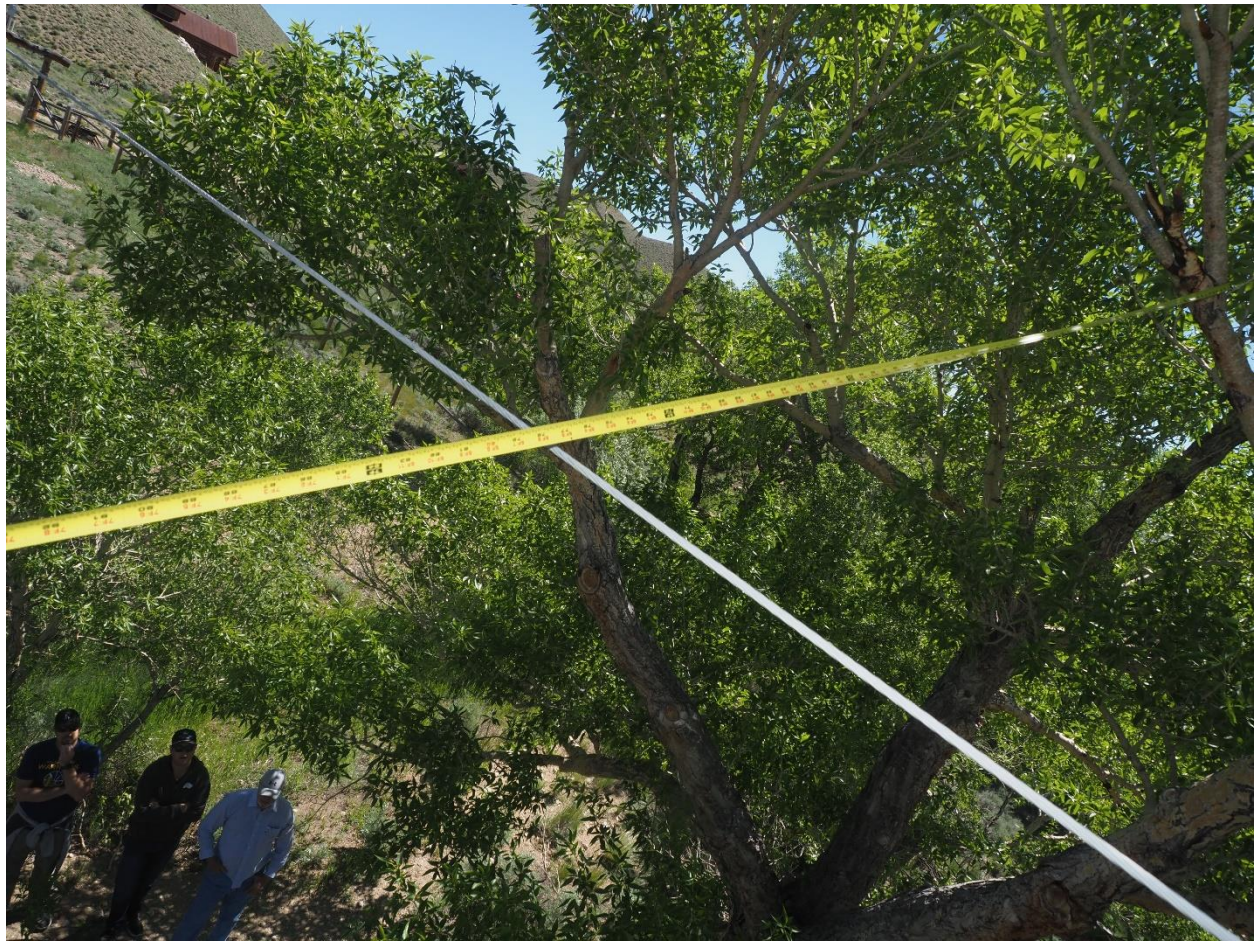
*Figure 2: Measurement of E-11 to Conductor during June Examination*

The distance from the power line to the E-11 branch was measured to be 78" as shown in Figure 2. The LiDAR measured distance was 60". The differences in the measurements could be attributed to the temperature as it was warmer in June than April and the conductor would have sagged more in the warmer temperature. The conductor was then pushed from the manlift toward the tree and the conductor moved approximately 4 feet closer to E-11. It was not possible to push the conductor to be within a foot of E-11.

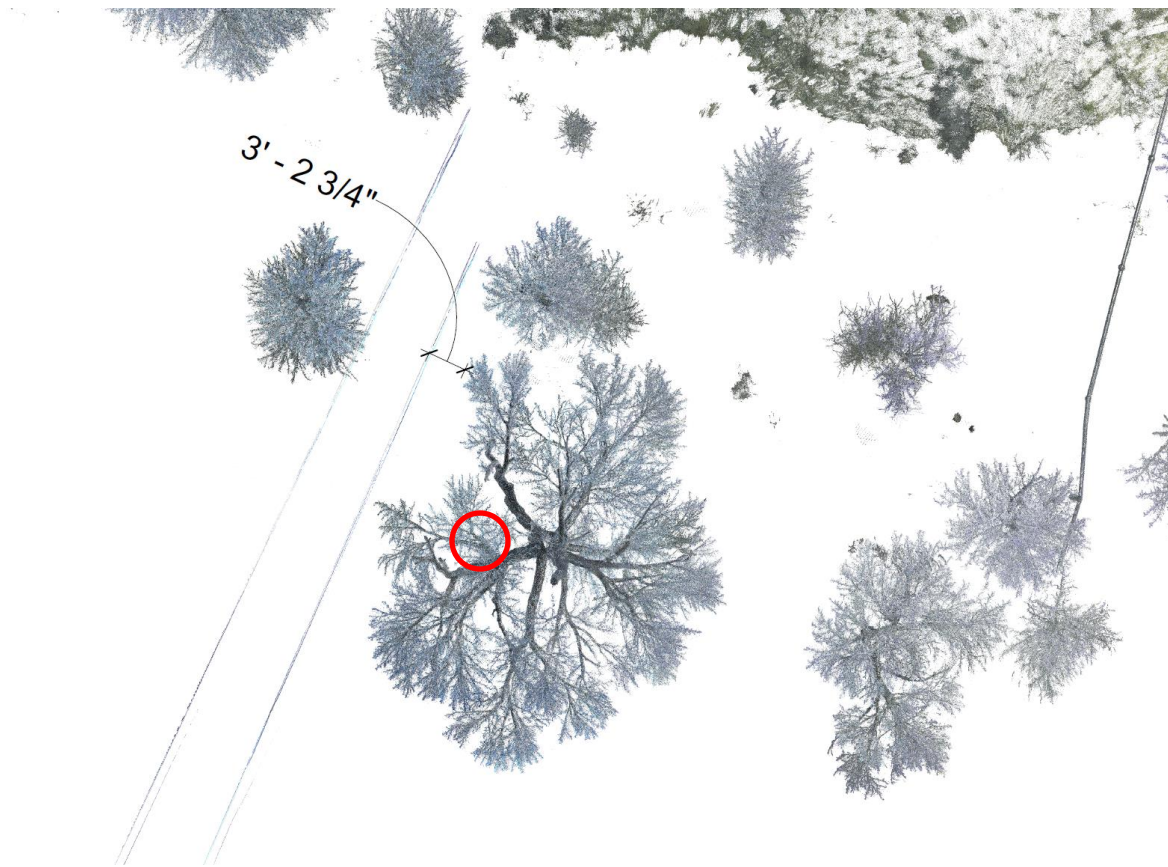
*Figure 3: GPRS 0034, LiDAR Closest Tree Branches to Conductor*

LiDAR measured the closest branches were to the north of E-11 and were approximately 43" from the conductor as shown in Figure 3. No burning was observed on these branches. E-11 is again indicated with the red circle.

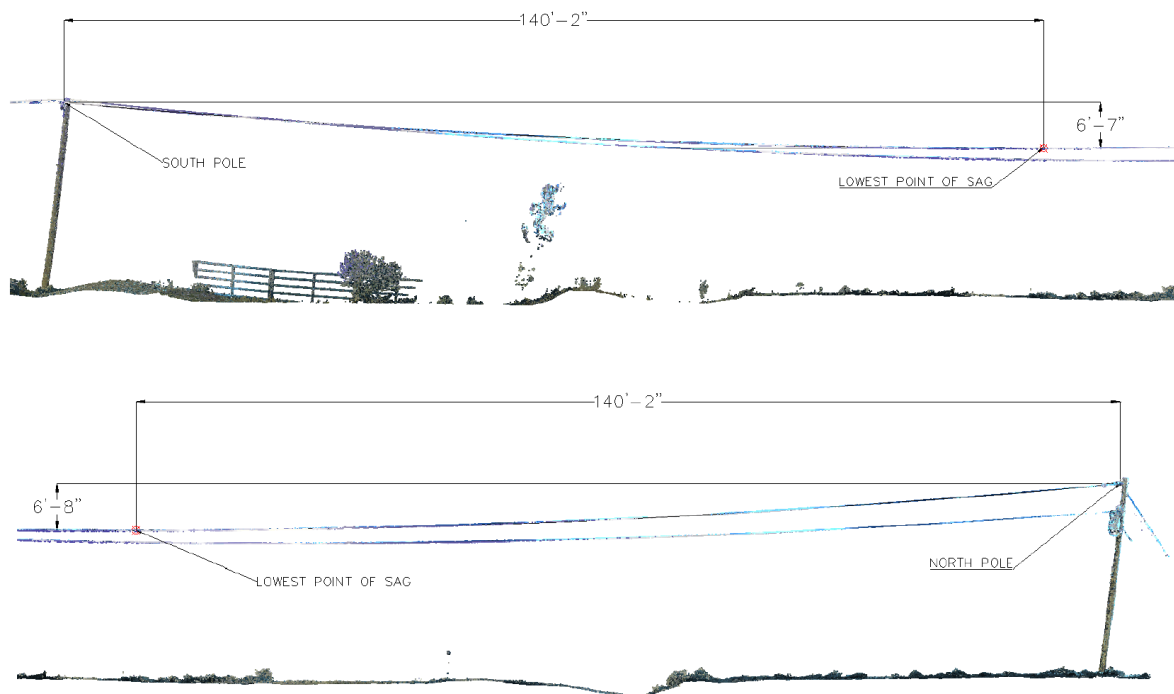
Figure 4: LiDAR Measured Sag of Conductor

The LiDAR measured the sag of the conductor to be 80 inches as shown in Figure 4. Notice the sag is the greatest in the middle of the span, but the subject tree is closer to the south pole, Figure 5. The distance the conductor can sway toward the tree at E-11 will be less than 80 inches, and therefore, the conductor would not be able to contact E-11.

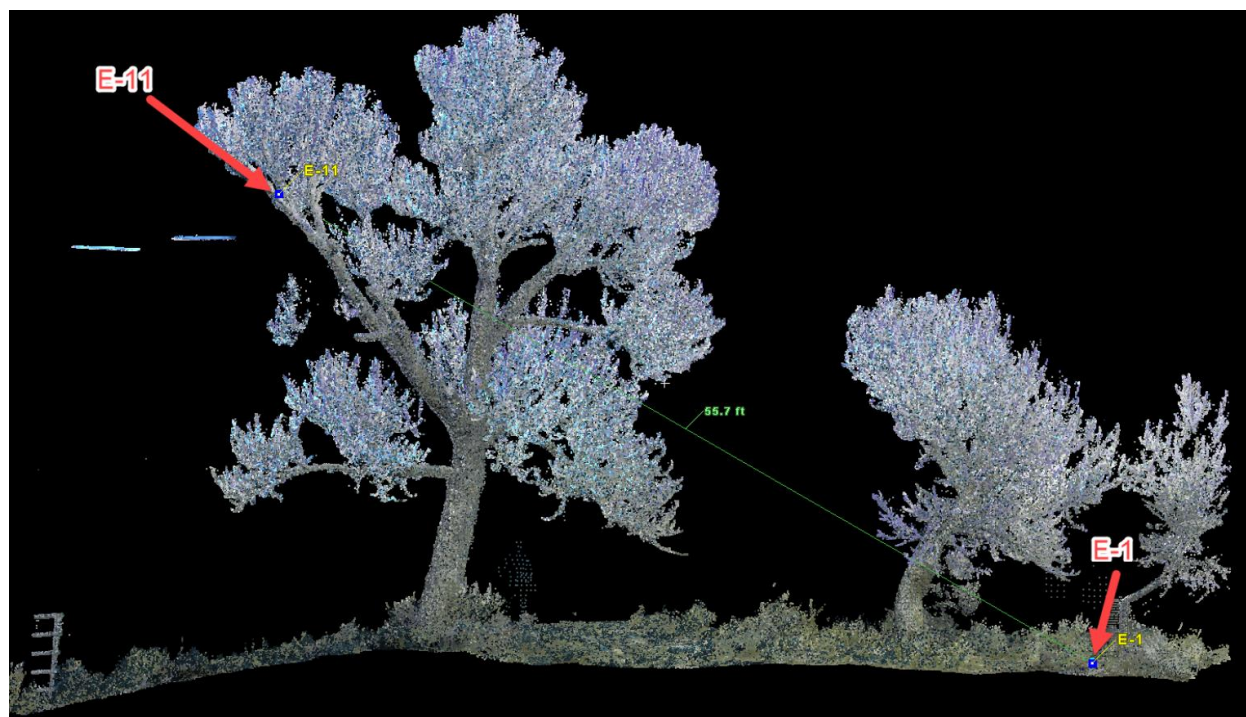
Figure 6: LiDAR Image of E-11 and E-1

A tree branch with burning was reportedly found east of the subject tree. The location was indicated by Pam Nelson. This location has been referred to as E-1 as indicated in Figure 6 from the LiDAR report. Figure 7 is a view from E-1 looking west toward the subject tree and E-11. The general location of E-11 is indicated by the red circle. The exact location can not be seen in the image because it is on the side of the tree away from view. Notice the measurement straight line through tree branches of two trees is 55.7 feet.

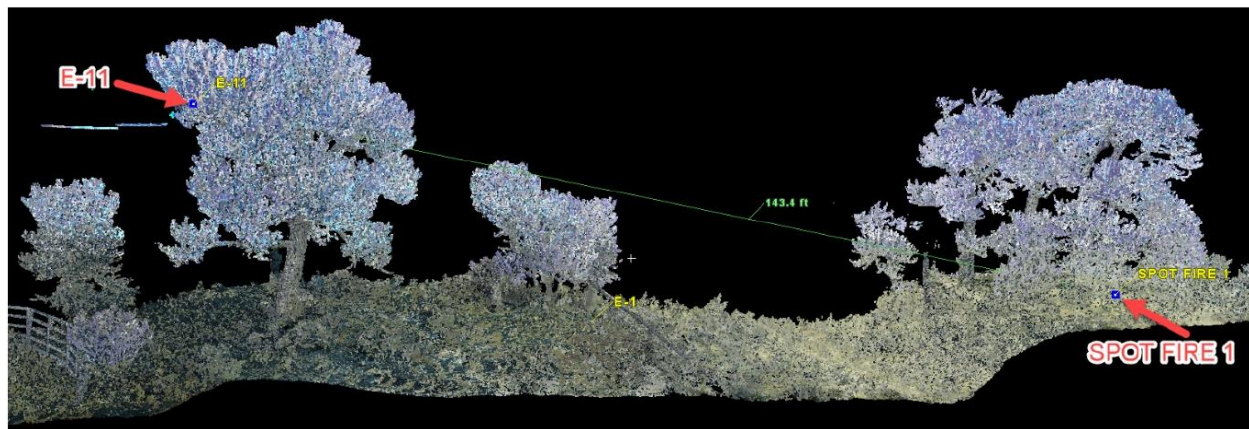
Figure 8: LiDAR Report GPRS 0019

The west most location of burning of vegetation was identified in the LiDAR scan as Spot Fire 1, Figure 8. The distance between E-11 and Spot Fire 1 was 143 feet. Notice there are multiple trees, shrubs and dry grass between the two locations and no fire was observed in that area. Figure 9 is an image from Spot Fire 1 looking west toward the subject tree. The subject tree is obscured by multiple trees.

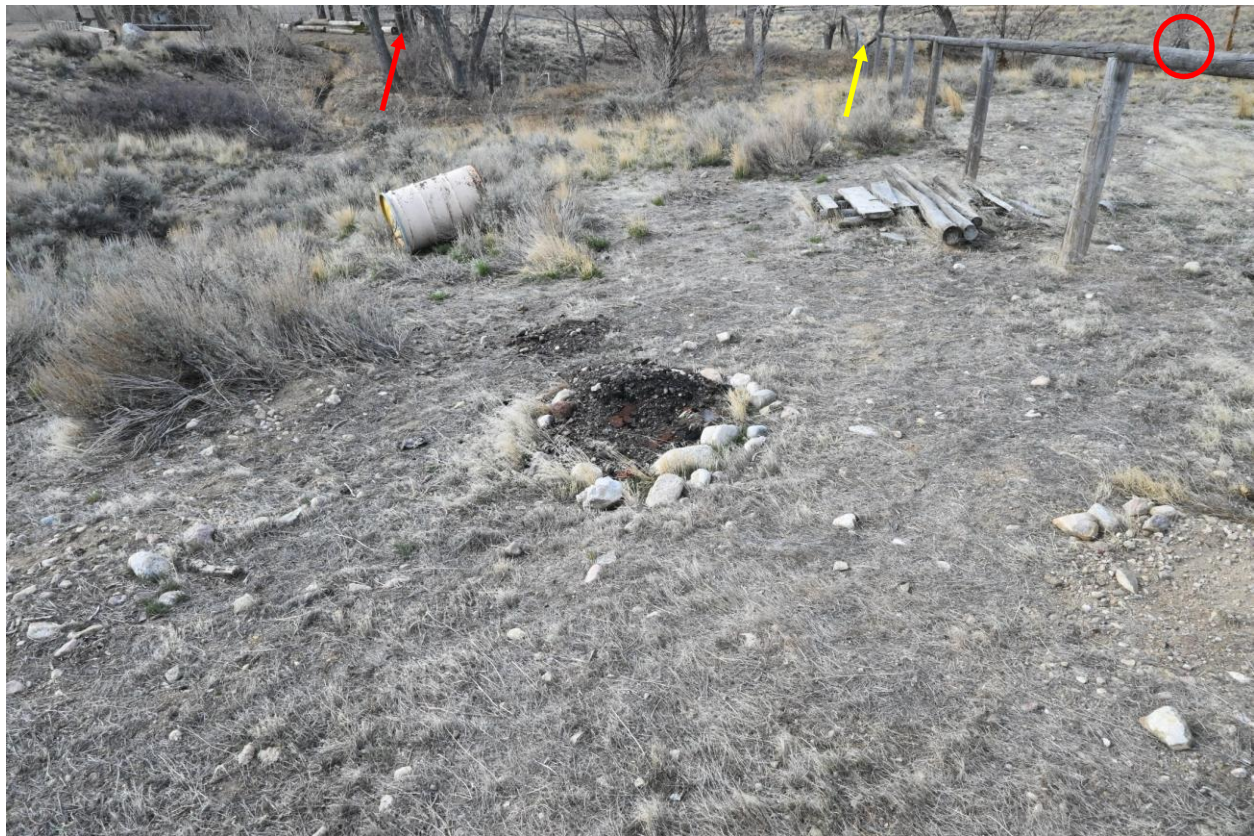
Figure 10: Image Looking South from the Driveway

Examination of the site revealed multiple fire rings. One such ring was just north of the fire area as shown in Figure 10. This image is looking south. The subject tree is indicated with the red circle. The western most Spot Fire 1 is indicated by the red arrow. The branch E-1 is indicated by the yellow arrow. It is possible the branch was from a previous campfire and it was transported to the location where it was found at some point in time and not related to the Clark Wildfire.

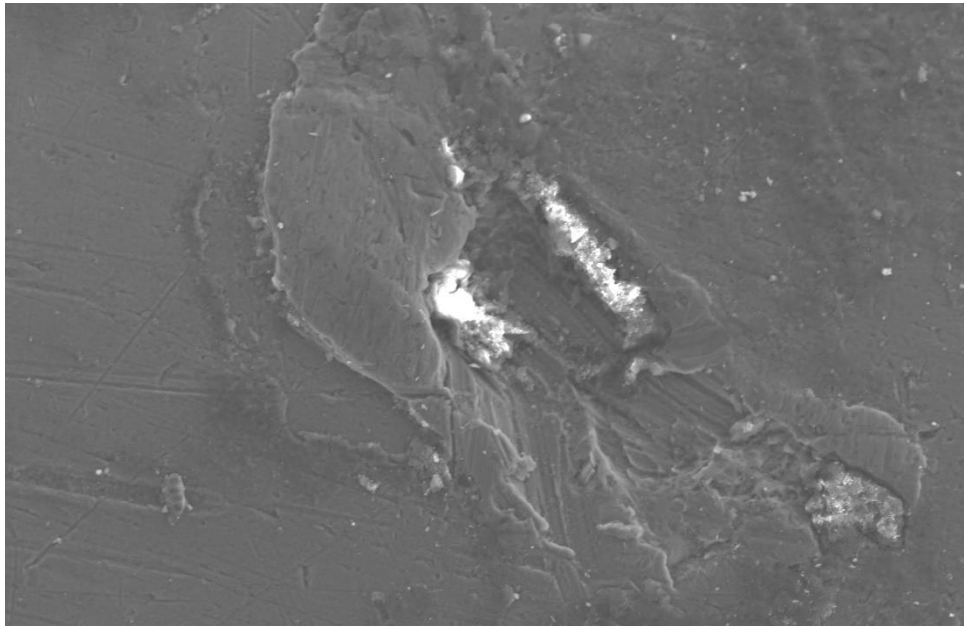
*Figure 11: SEM Image of Deformation*

The conductor was examined visually with a Keyence digital microscope (KDM) and Scanning Electron Microscope (SEM). The conductor is made of Aluminum strands on the outside with a steel core strand for strength (ACSR). The aluminum strands were examined and no evidence of arcing was observed. There were deformations due to mechanical impact with a rock or other hard object as shown in Figure 11. Notice striation lines in the deformation due to something sliding and gauging the aluminum strand. There was no evidence of thermal melting. Thermal melting causes the aluminum to soften and become liquid which would leave a rounded and flowed surface.

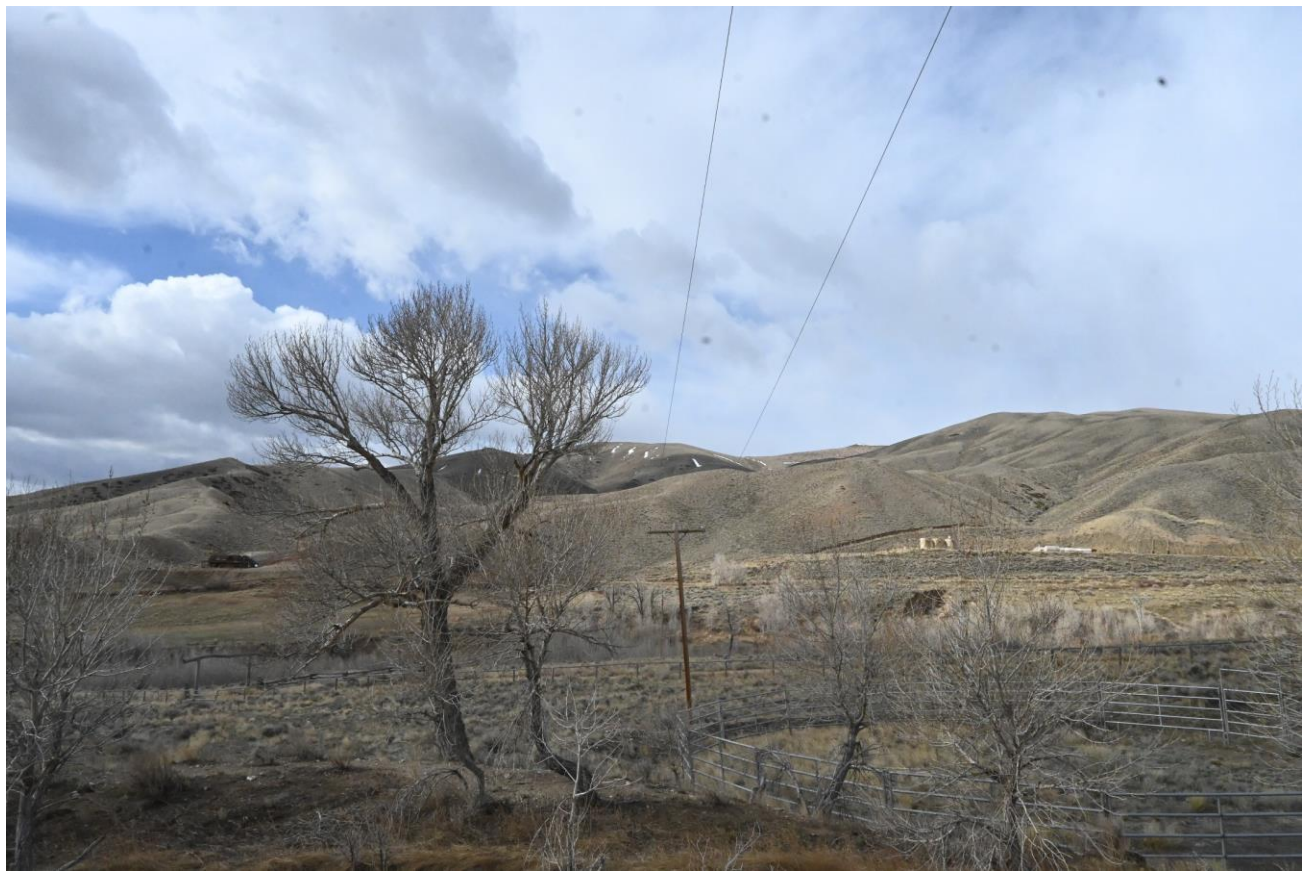
*Figure 12: Image taken from the Driveway Looking South Along Power Line*

The Jensen Hughes report dated August 14, 2023, was provided as the Plaintiff Electrical investigative report. The executive summary stated the fire was caused by power line to tree contact. It stated “Asplundh chose not to trim the subject tree based on a visual inspection performed from outside the property at a distance of approximately 300 feet.” The Asplundh inspector, Perry Toler, testified that he was approximately 35 feet<sup>1</sup> from the tree. Figure 12 was taken from the approximate location where Mr. Toler testified that he viewed the tree clearance.

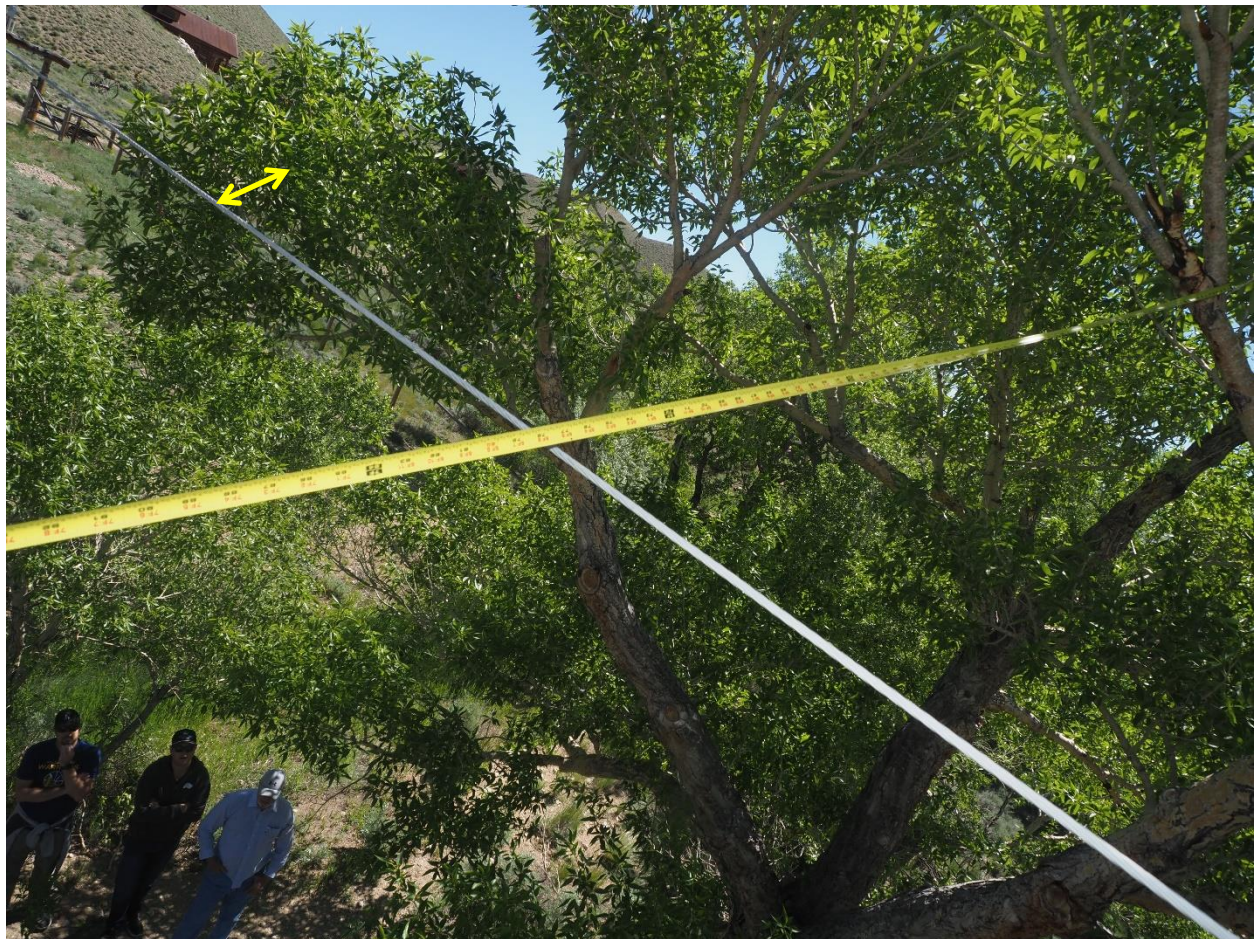
*Figure2: Measurement of E-11 to Conductor during June Examination*

Page 10 of the Jensen Hughes report stated “LiDAR scanning was performed at the Hutton property on April 20, 2022, and portions of the subject tree’s crown were measured to be 3.5 feet away from the distribution line’s phase conductor.” The report fails to mention that these tree branches were 2 feet closer to the phase conductor than E-11 and did not contain any burning or contact marks on them. These branches were further north on the tree and closer to the middle of the span. The conductor has more sag at that location and therefore, the phase conductor would have contacted these branches before it contacted E-11. The location of the branches is shown in Figure 2, copied below.

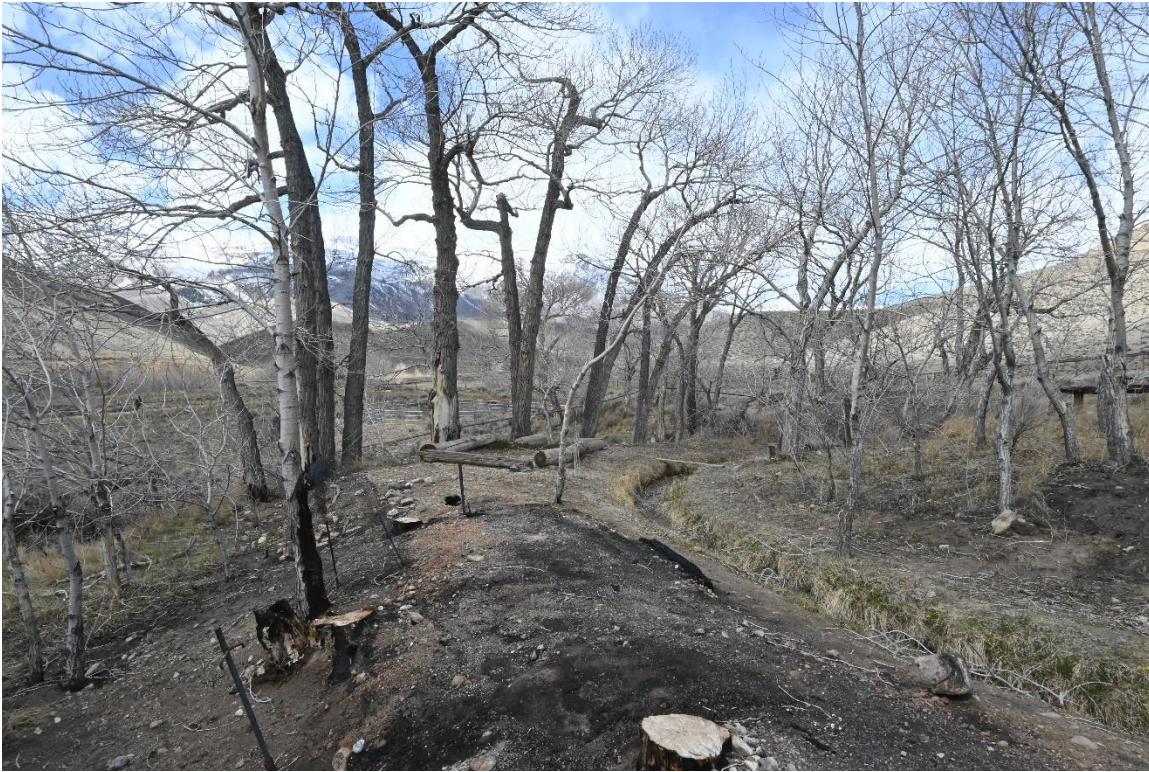
*Figure 13: View from the Outbuilding Looking West*

In the same paragraph on page 10 the report stated, "Twigs found near the outbuilding had areas of discoloration that were consistent with utility line contact." Two photographs taken by IRIS were referenced showing burned twigs on the east side of the outbuilding. This was well within the fire area. Figure 1 from the Jensen Hughes report is below showing the aerial view. The blue arrow indicates the Spot Fire 1 location. Notice the Outbuilding is east of this fire location. There were multiple burned trees around the outbuilding that it is more likely where the twigs were from, than the subject tree. Figure 13 is a view from the Outbuilding looking west showing multiple burned trees and lots of burned twigs on the ground. The subject tree is obscured by multiple trees.

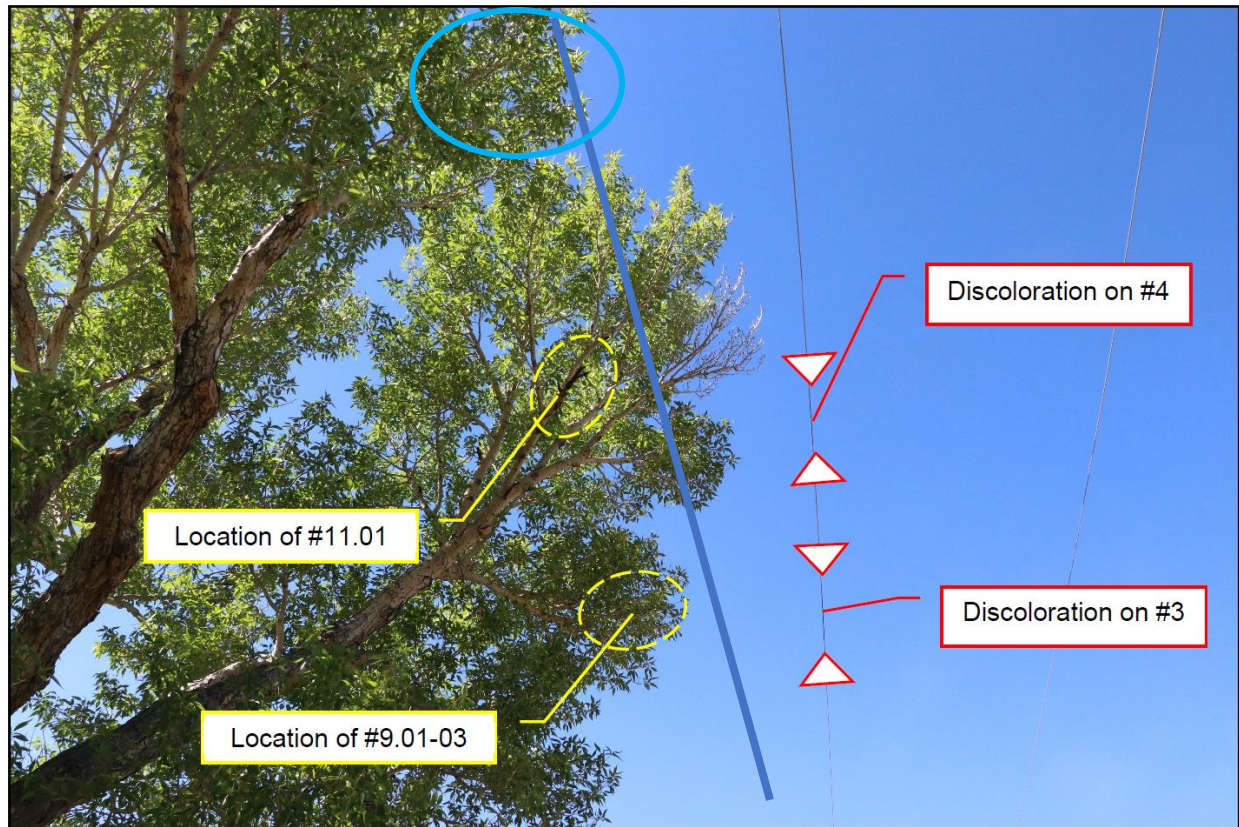
Figure 14 - Locations of line discoloration in relation to burn indicators on the subject tree.

Page 32 of the report discusses the locations of discoloration and tree branch artifacts as shown in Figure 14 from the report below. The analysis and Figure 14 fail to address that the LiDAR scan identified the tree branches circled in blue were much closer to the conductor the E-11 or E-9 and was closer to the midpoint of the span where the lateral sway is the greatest. The blue line is an exaggeration of the conductor sway to show lateral sway would have contacted the branches to the north before either the E-11 or E-9 locations. Those branches were not collected for further examination. Golden's examination of those branches at the site revealed no burning or evidence of line contact.
